## REPORT NO. 95-19

# HIGH MOBILITY TRAILER (HMT) TRANSPORTABILITY TESTING

A. BACKGROUND. The U.S. Army Defense Ammunition Center and School (USADACS), Validation Engineering Division (SIOAC-DEV), was tasked by U.S. Army Tank-automotive and Armaments Command (TACOM) to perform transportability tests for ammunition loaded on the M1102 High Mobility Trailer (HMT).

C. OBJECTIVE. The objective of these tests was to assess the ability of the HMT to safely transport ammunition by rail and on/off-highway.

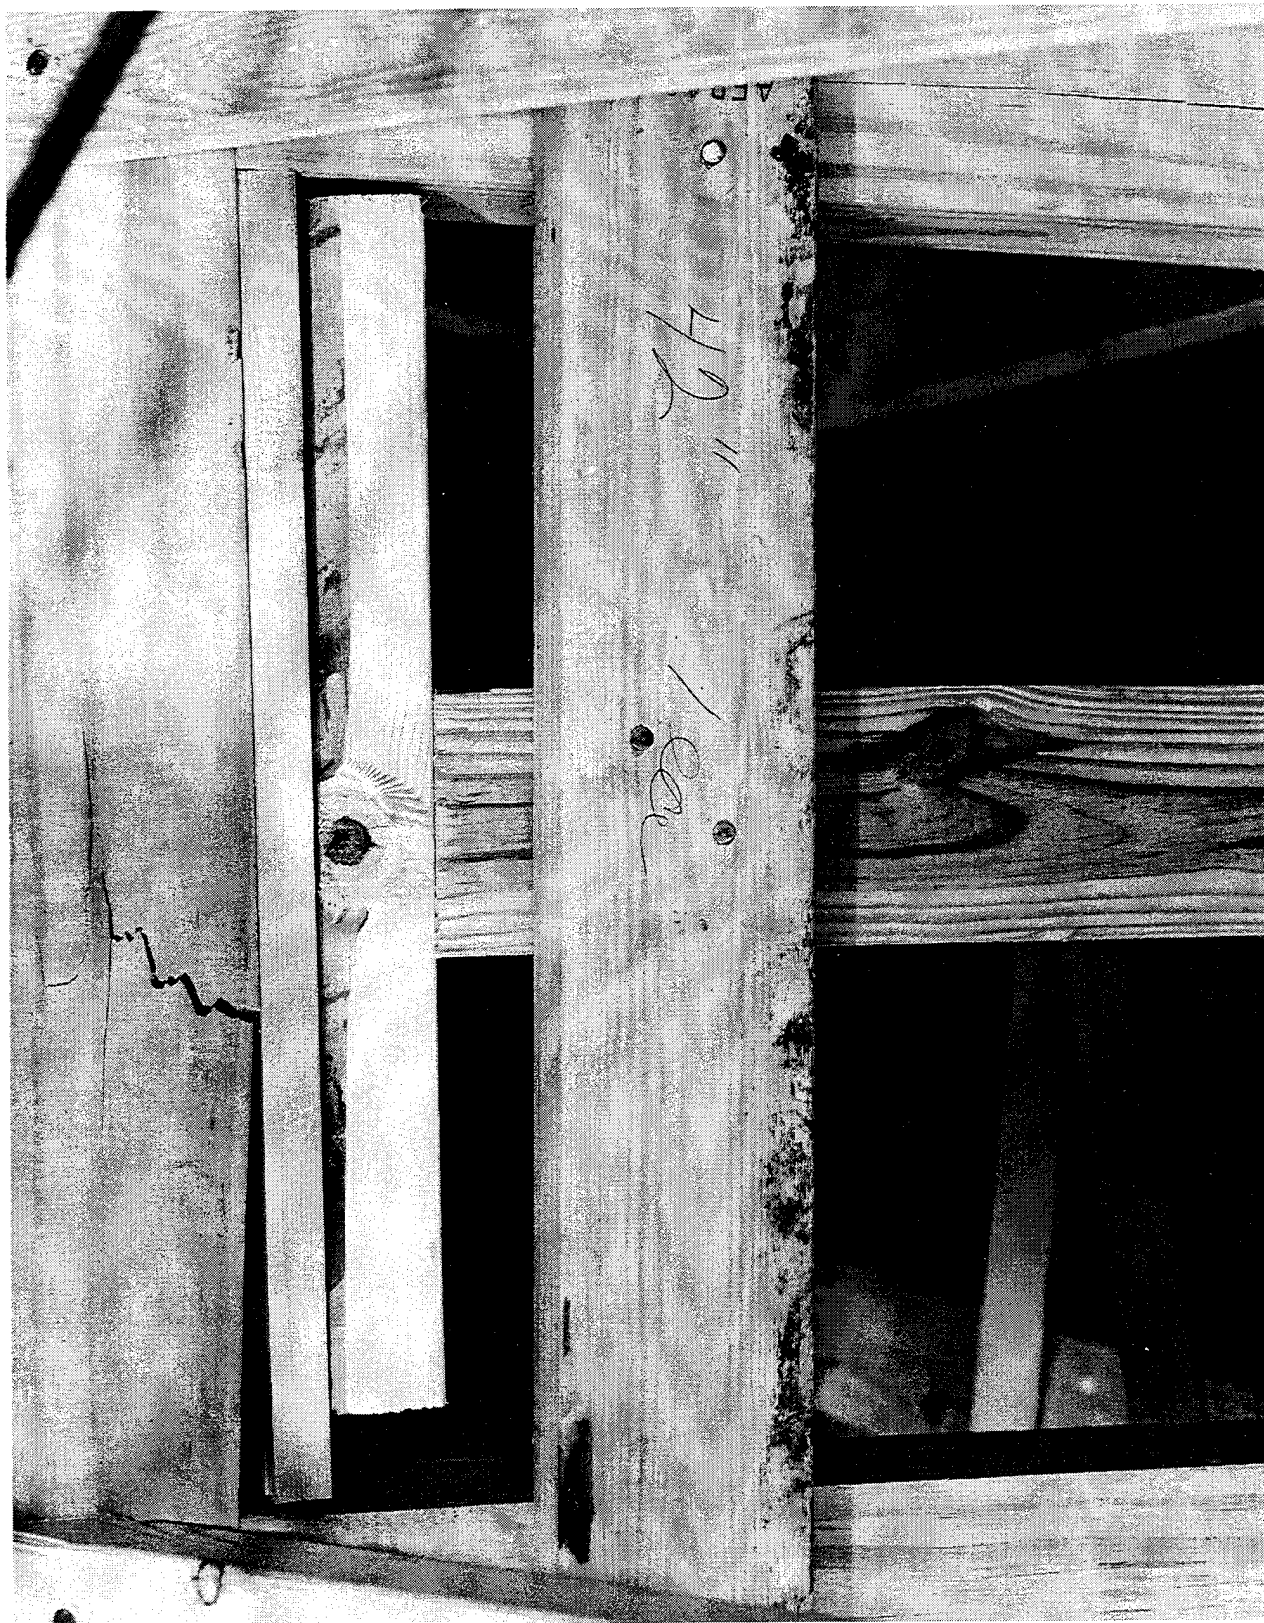
AO317-SCN96-7-291. This photo shows the crack in the stanchion. The stanchion was reinforced as shown.

2. Six 3/8-inch steel wire ropes (cables) were used to secure the loaded trailer to the flatcar, one rope/cable through each of the four trailer tiedown anchors and two ropes/cables through the lunette of the tongue. The trailer tongue was placed on a stanchion and the jack was removed. The stanchion cracked while the HMT was being cabled and was reinforced prior to testing (see photo on page 6-3). The aft end of the loaded HMT was forward for rail impact tests at nominal speeds of 4, 6, and 8.1 mph. The front end wall was forward for the reverse 8.1 mph impact.

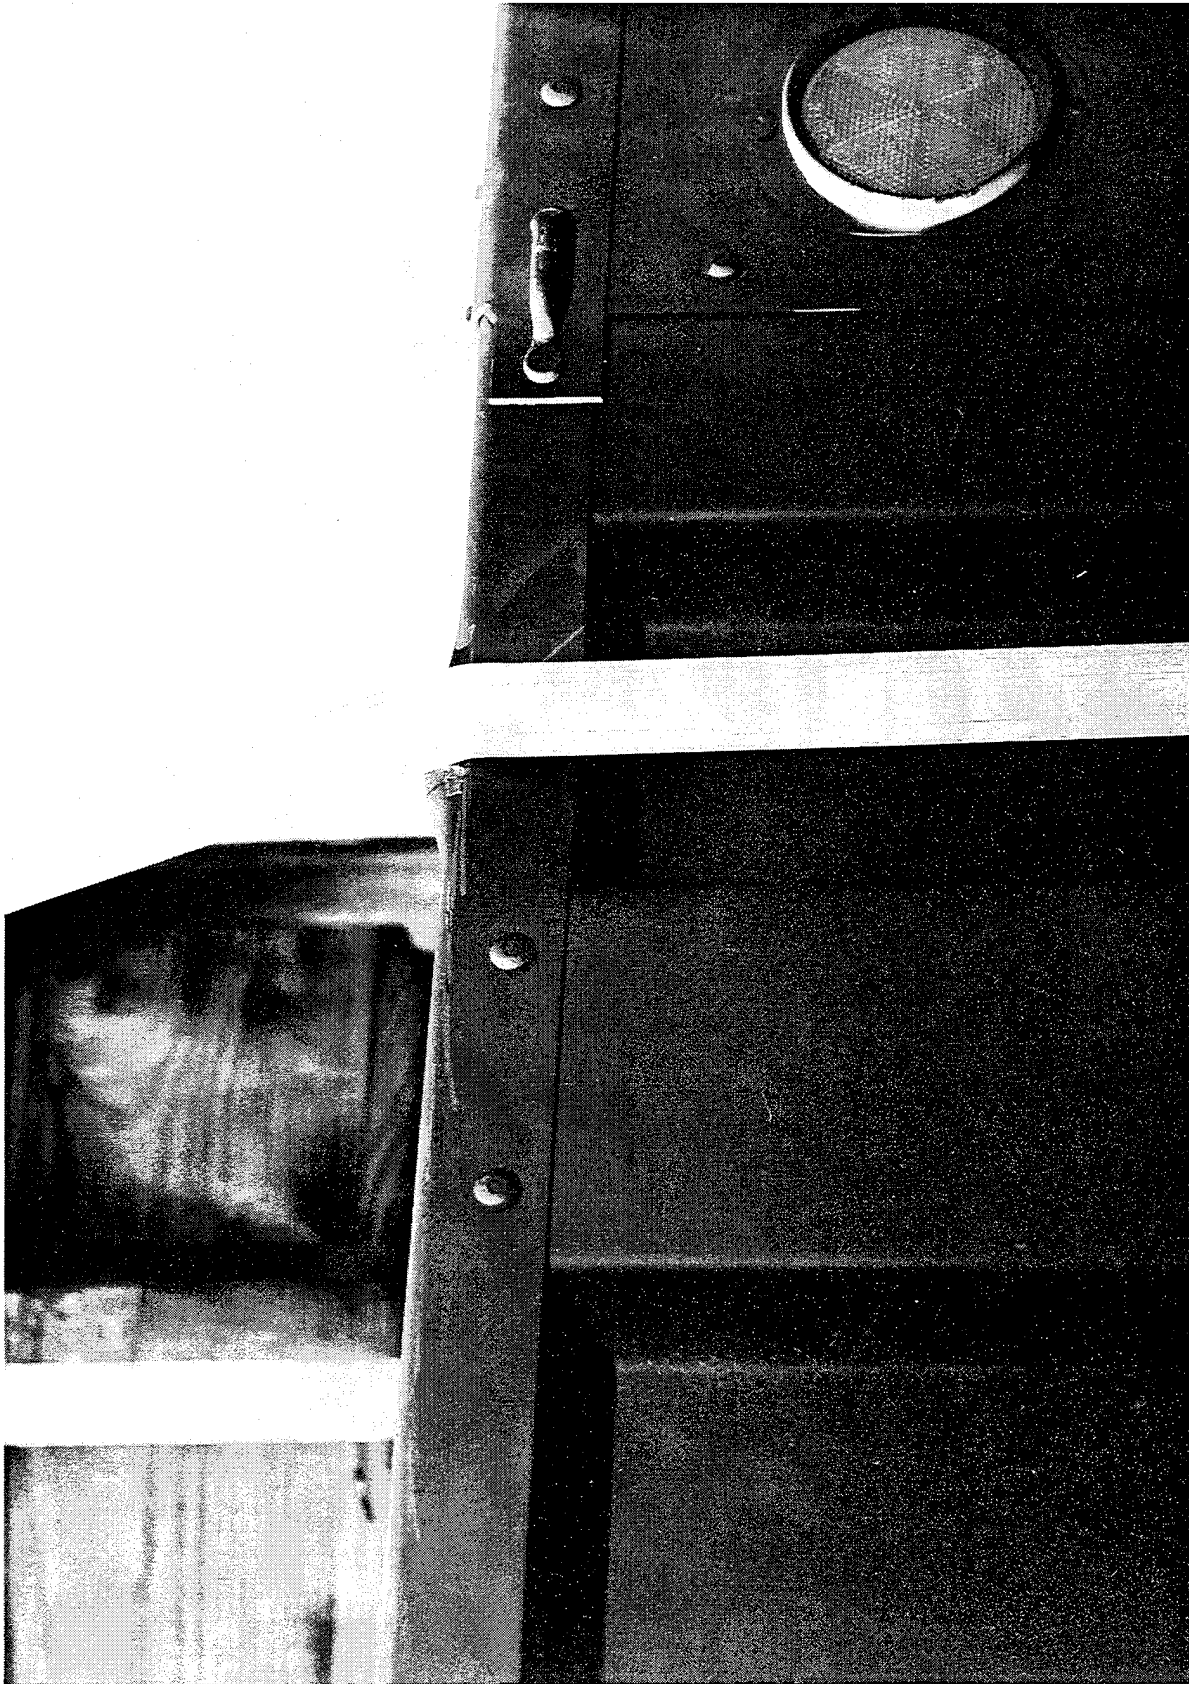
| AO317-SCN96-7-290. This photo shows the load blocked against the forward end wall. Note the indentation in the side wall due to the 1-1/4-inch steel strap encircling the HMT and the pallet unit. | | |

3. The 6 mph impact produced slight deformation in the top lip of the cargo bed sidewall (see photo on page 6-4). The deformation occurred where the steel strap at the front of the HMT crosses the sidewall lip. The 8.1 mph impact increased the deformation in the lip of the cargo
